AUDIT REPORT

PUBLIC LIGHTING ASSETS

Sunshine Coast Council

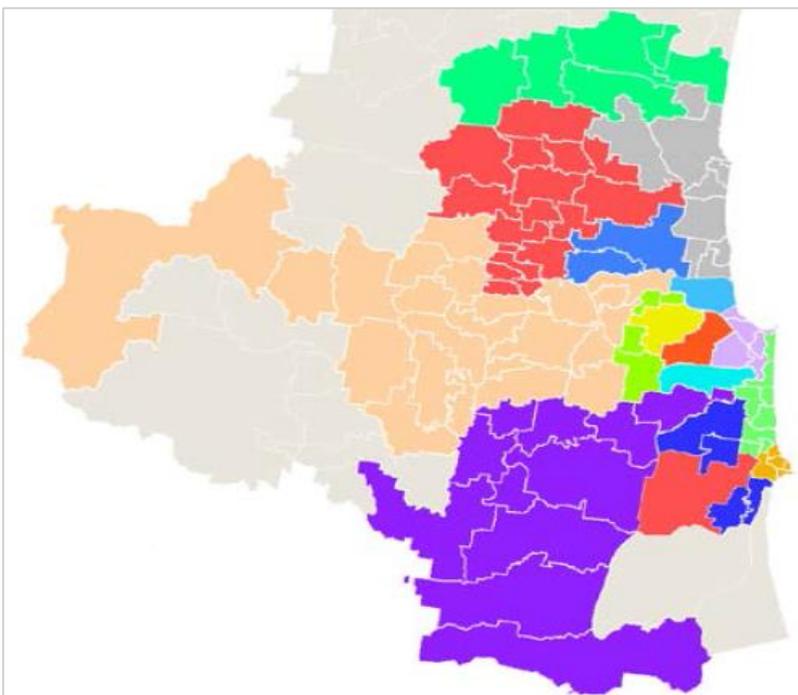
Figure 1. Geographic Segmentation

The geographic audit area was divided into 16 segments, based upon the density and locality of each area. Areas that contain a fewer number of lighting assets were identified as being able to be audited by a roaming audit team, whilst coastal areas that contain a higher density of lighting points were identified as requiring a larger amount of time and resources during the field work.
